# Debris/Ice/TPS Assessment And Integrated Photographic Analysis For Shuttle Mission STS-46

September 1992

DEBRIS/ICE/TPS ASSESSMENT  
AND  
PHOTOGRAPHIC ANALYSIS  
OF  
SHUTTLE MISSION STS-46

July 31, 1992

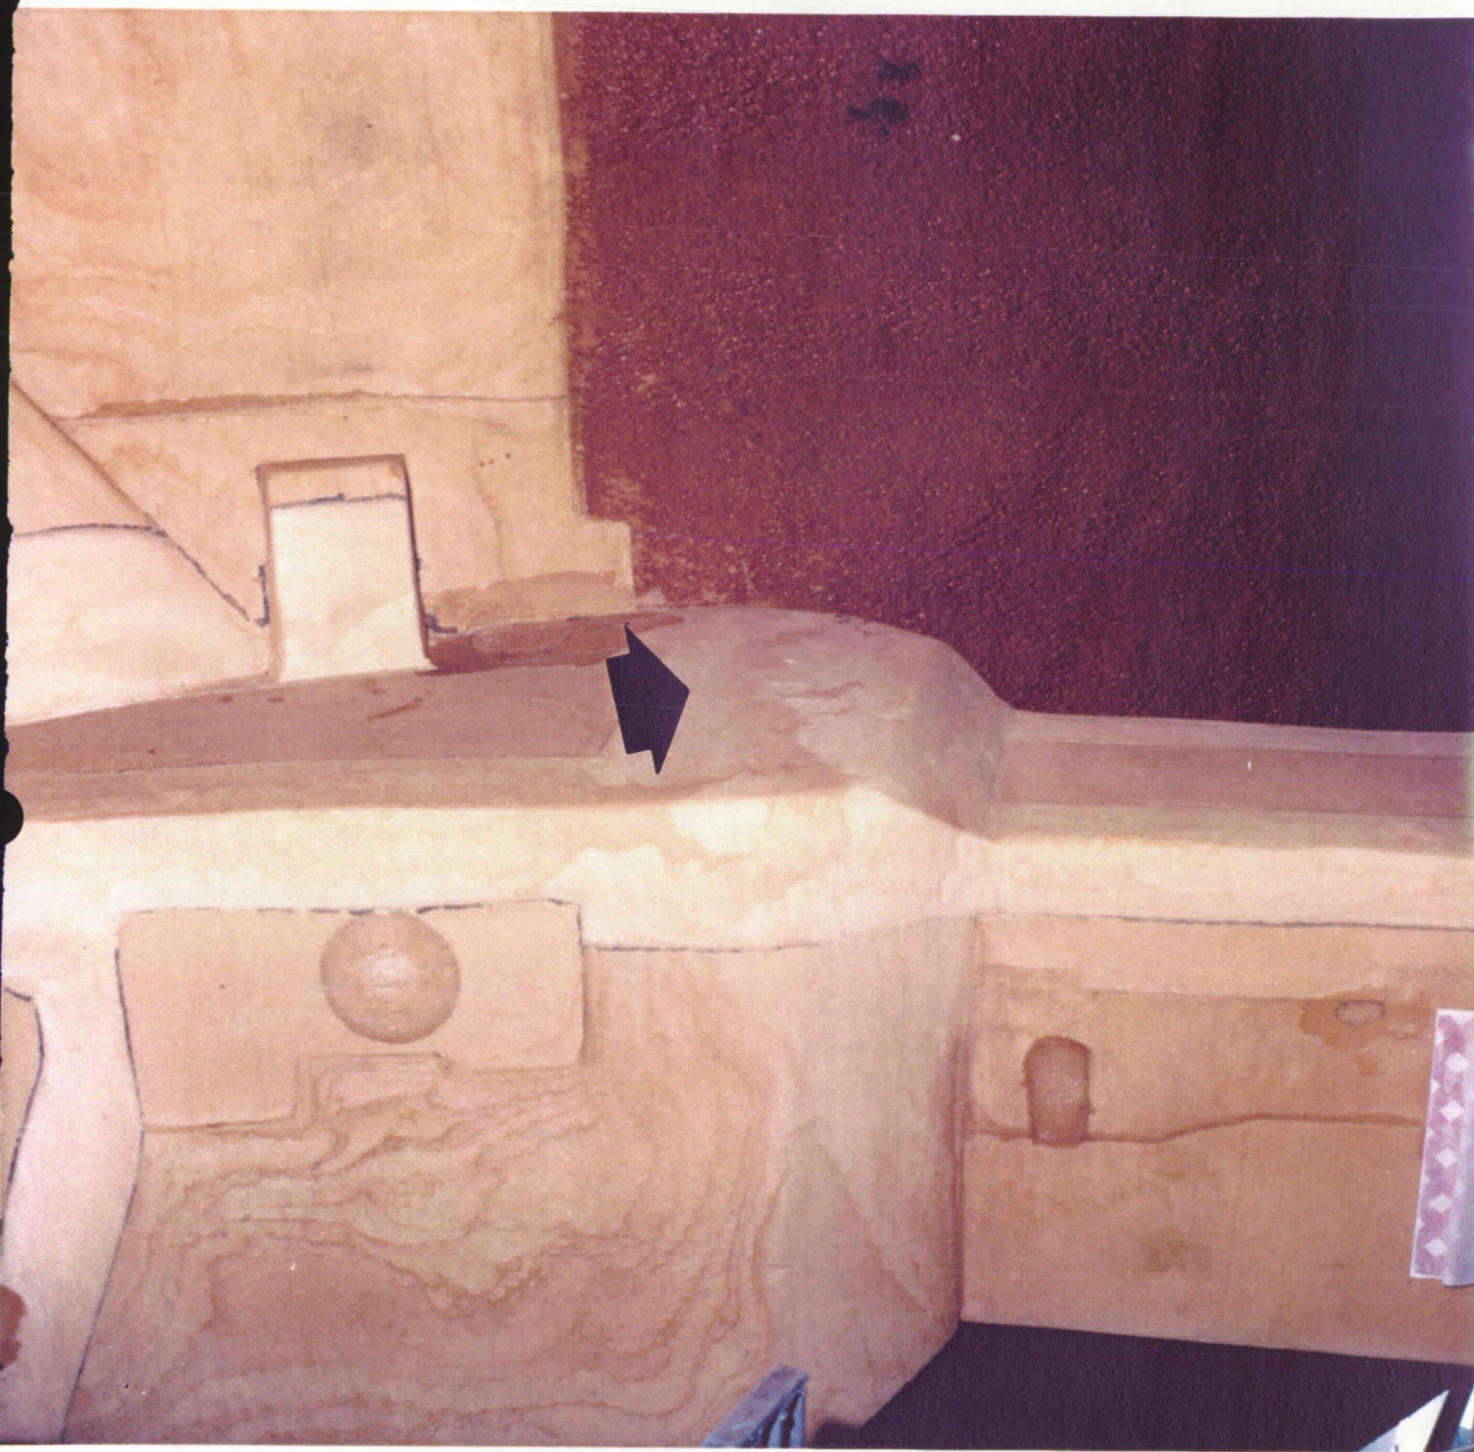
LH (-Y) vertical strut/cable tray TPS covering prior to cryogenic fuel loading. Cracks have appeared in this general area after cryoload due to the elimination of a stress relief gap as part of a manufacturing process enhancement change.

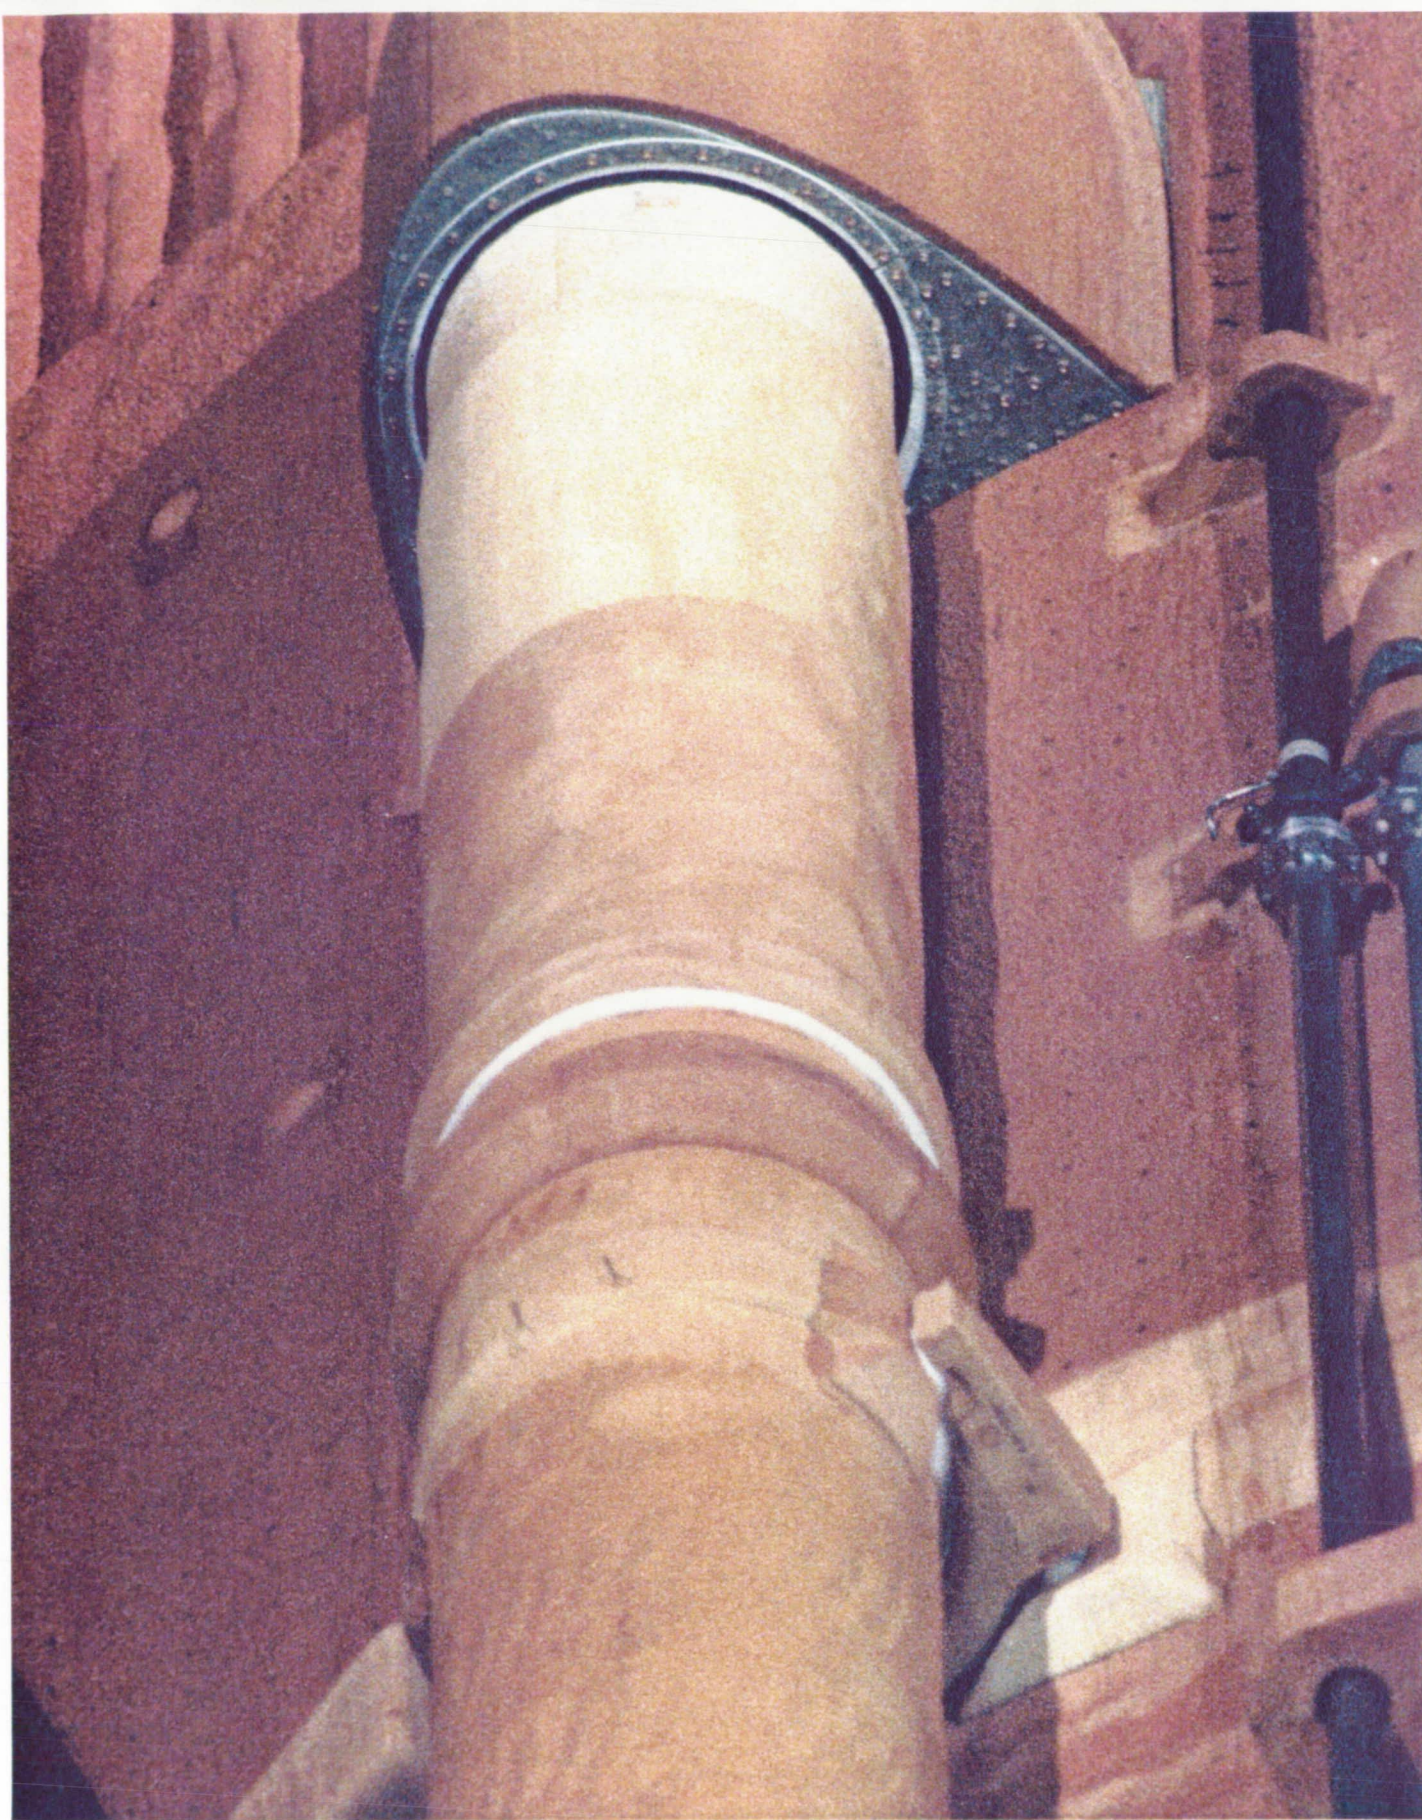
Anomaly 006 (documentation only) recorded ice/frost formations in the LO2 feedline bellows and support brackets. These ice and frost formations were acceptable per NSTS-08303.

Typical amounts of ice/frost had formed in the L02 feedline support bracket and upper bellows

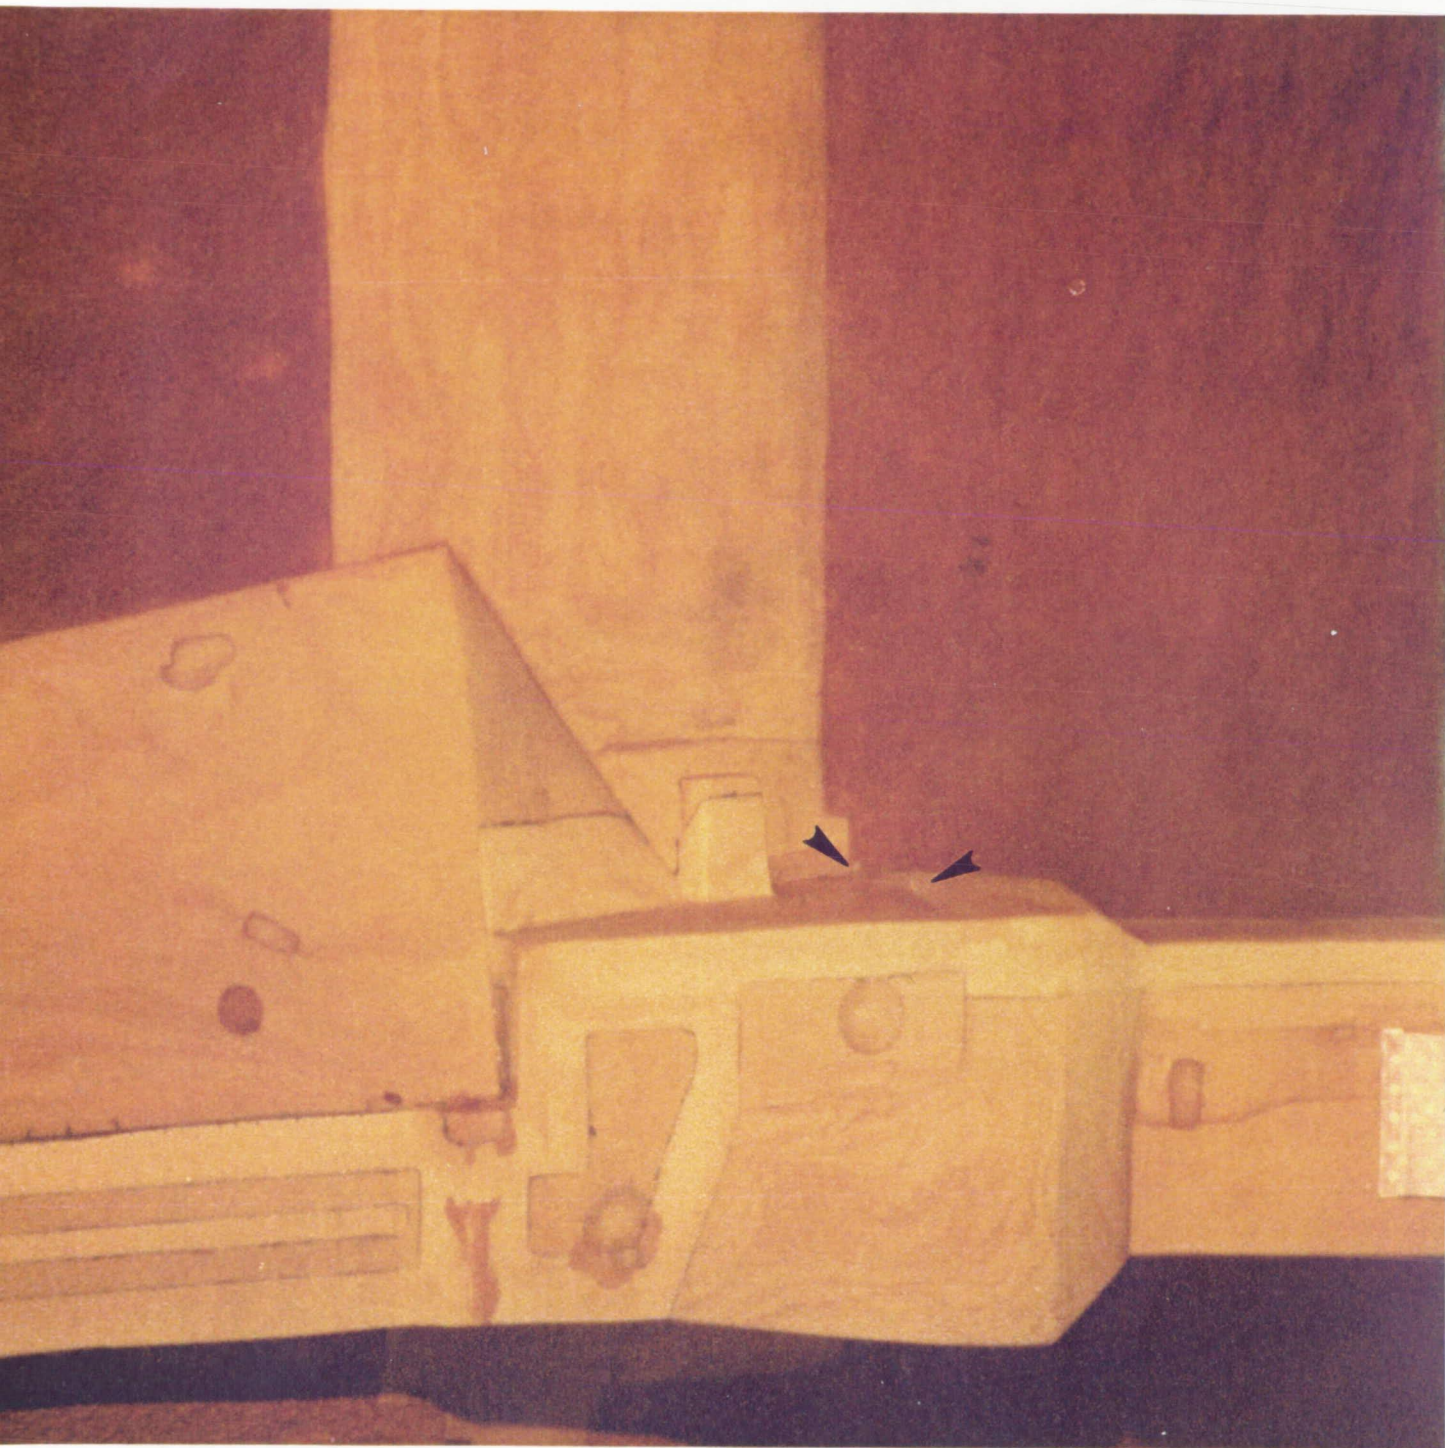
Anomaly 002 and PR ET-48-TS-0027 documented two cracks (8 and 4 inches, respectively, and 1/4-inch wide) in the forward surface TPS covering of the -Y vertical strut cable tray near the longeron closeout interface. Both cracks exhibited no offset and were not filled with ice or frost. Due to the proximity of

Two cracks, 8 and 4 inches long, respectively, appeared in the LH (-Y) vertical strut/cable tray forward facing TPS covering near the longeron closeout interface. A stress relief cut in the TPS to allow for structural movement had been deleted by design.

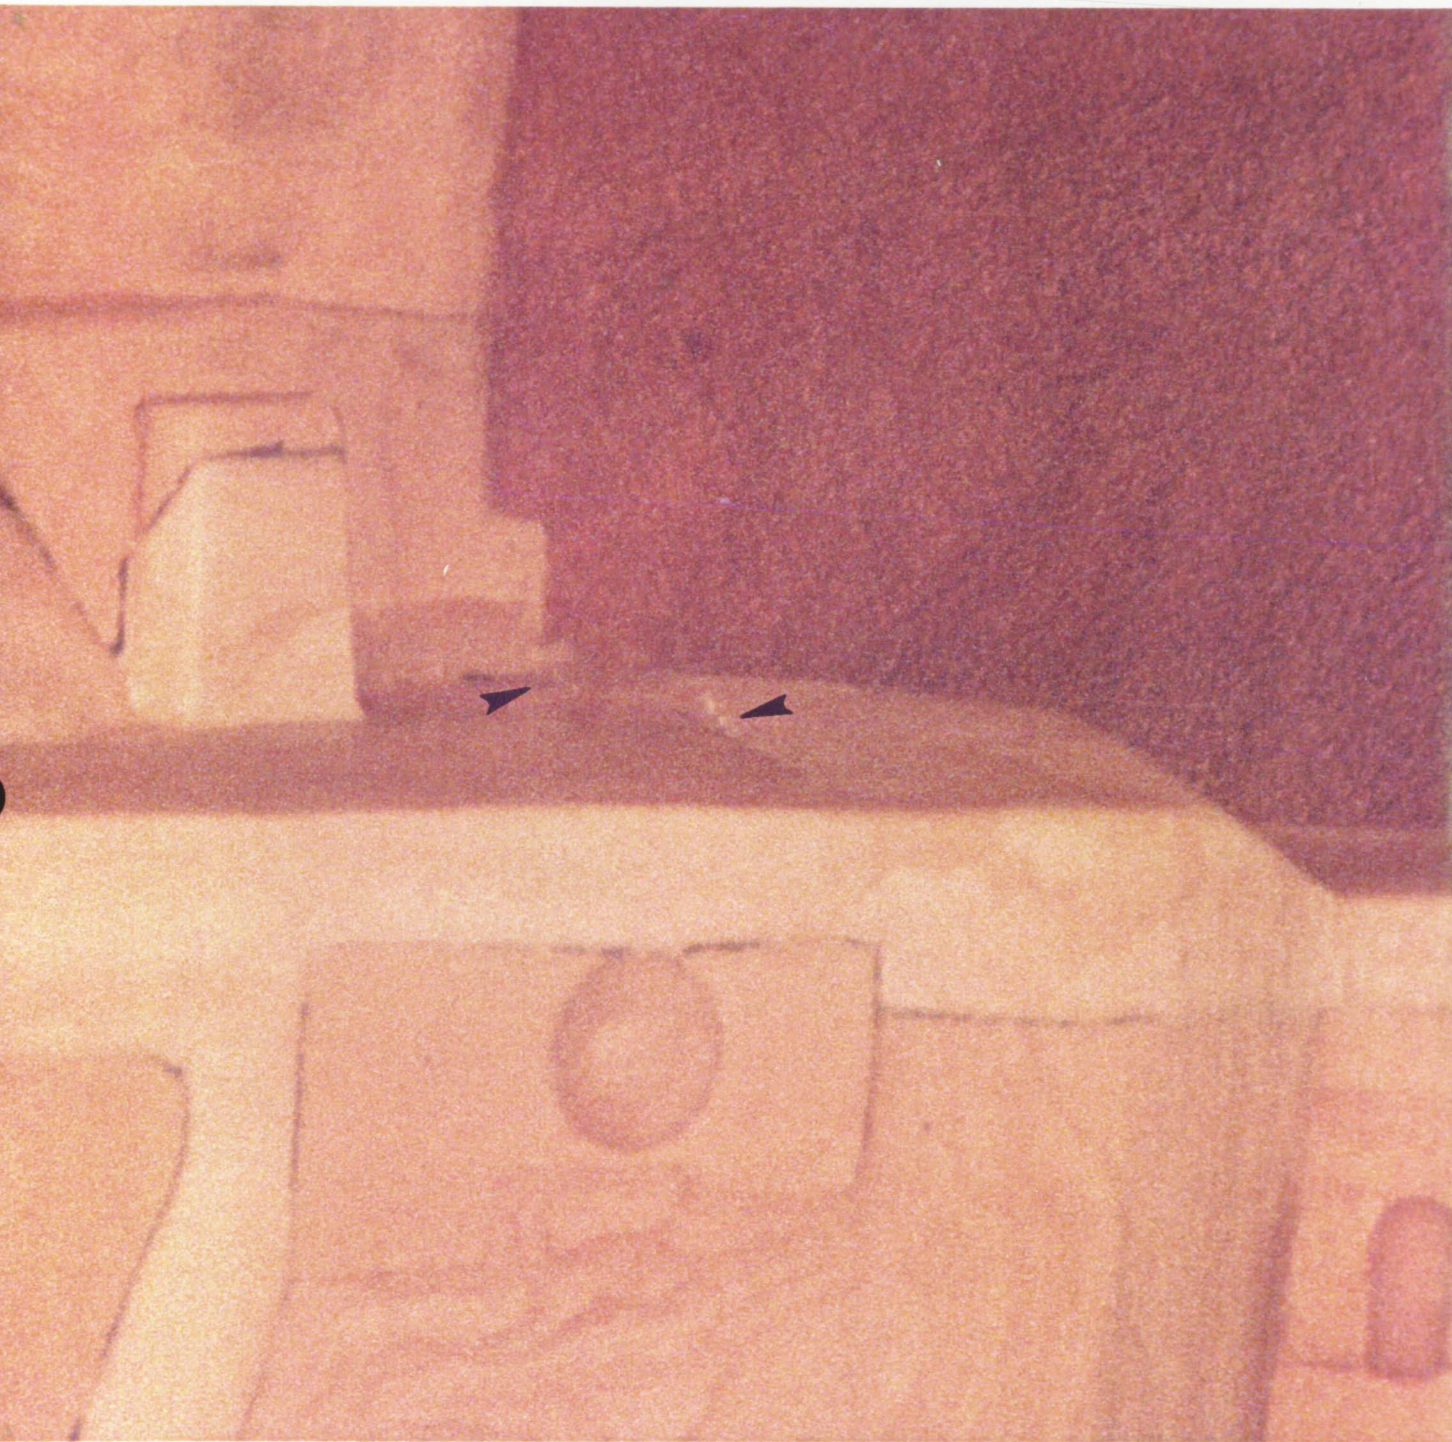
the cracks, the possibility existed for loss of BX-250 TPS in flight. Thermal and flow field analyses showed no aerothermal or debris concerns.

Both cracks exhibited no offset and were not filled with ice or frost. Due to the proximity of the cracks, the possibility existed for loss of BX-250 TPS in flight. Thermal and flow field analyses showed no aerothermal or debris concerns.

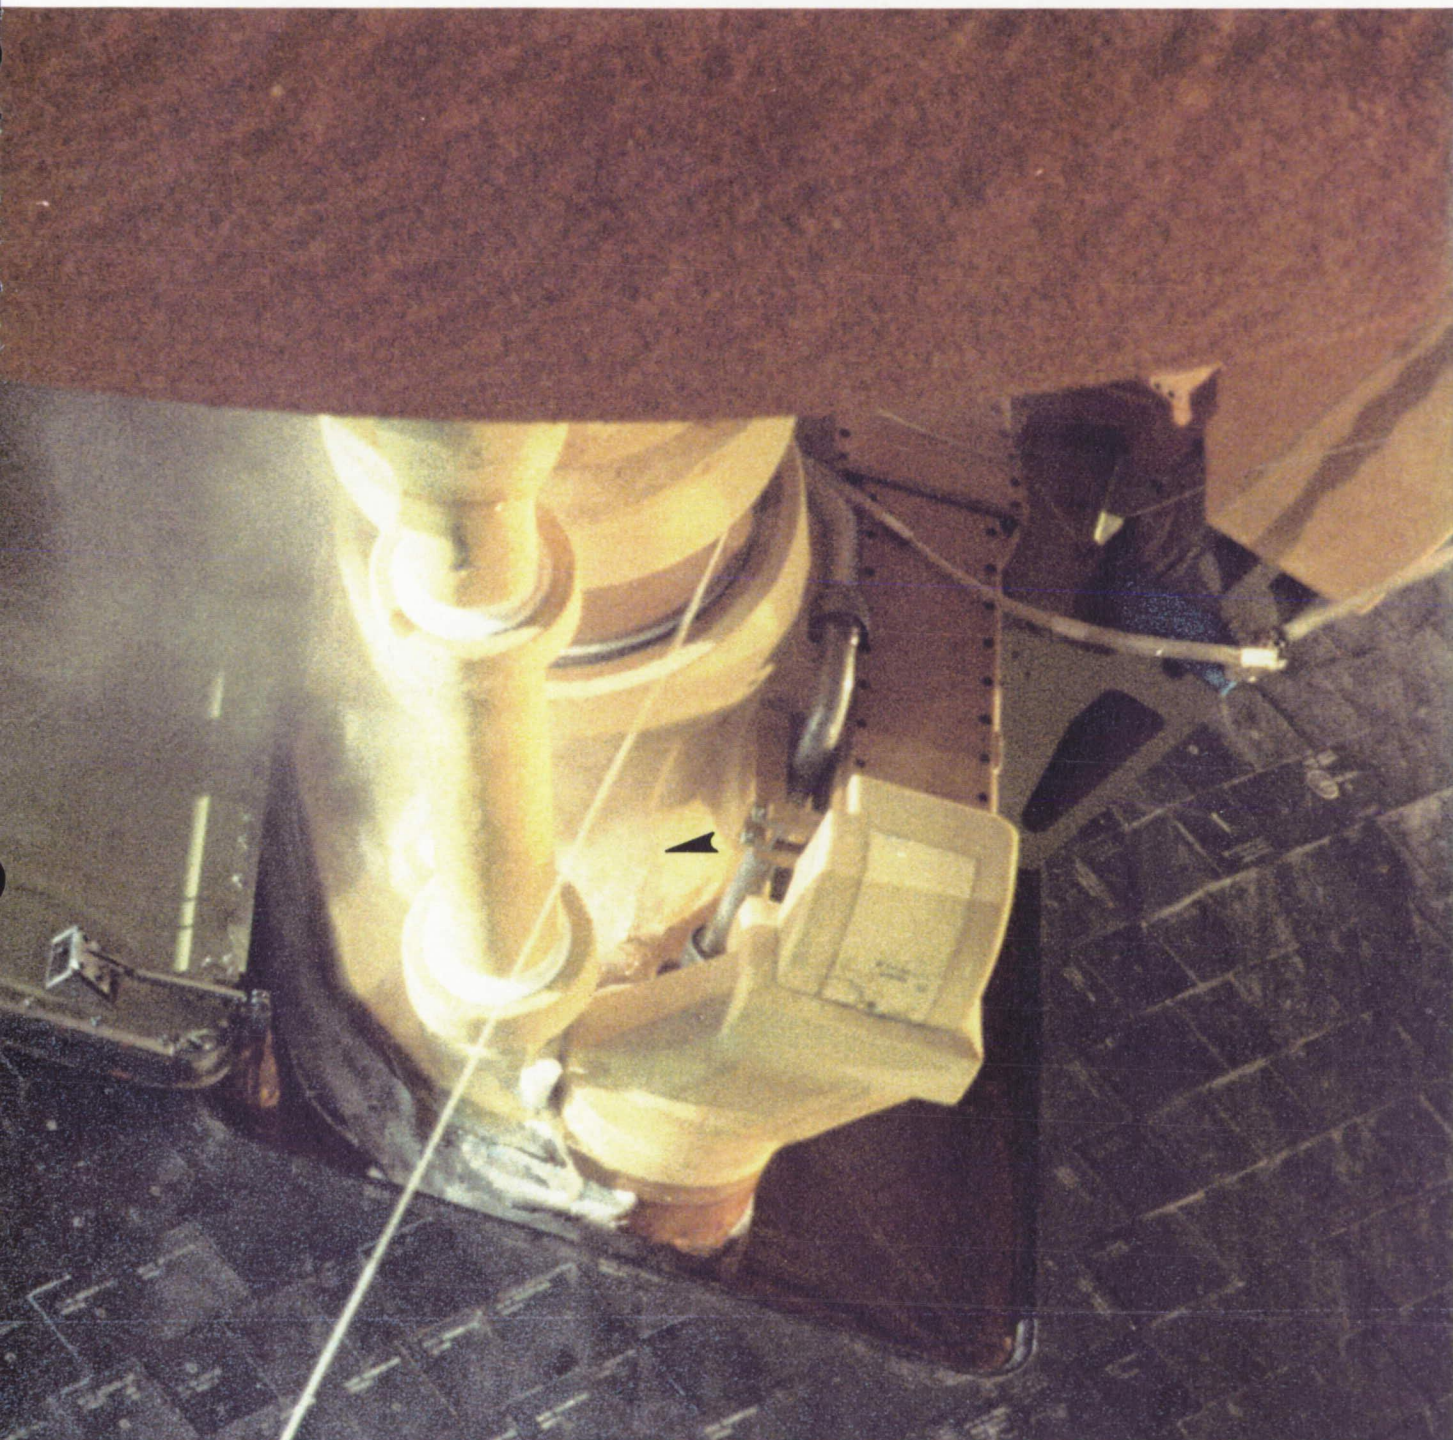
Ice/frost formations on the inboard side of the LH2 ET/ORB umbilical/purge barrier, the lower plate gap purge vent, and in the LH2 recirculation line bellows were typical. Ice/frost accumulated on the thin foam and bondline around the aft pyro canister. Ice, 8"x4" in size, had formed at the forward corner of the 17-inch flapper valve actuator access port foam plug closeout. A strong flow of purge gas vented from this area.

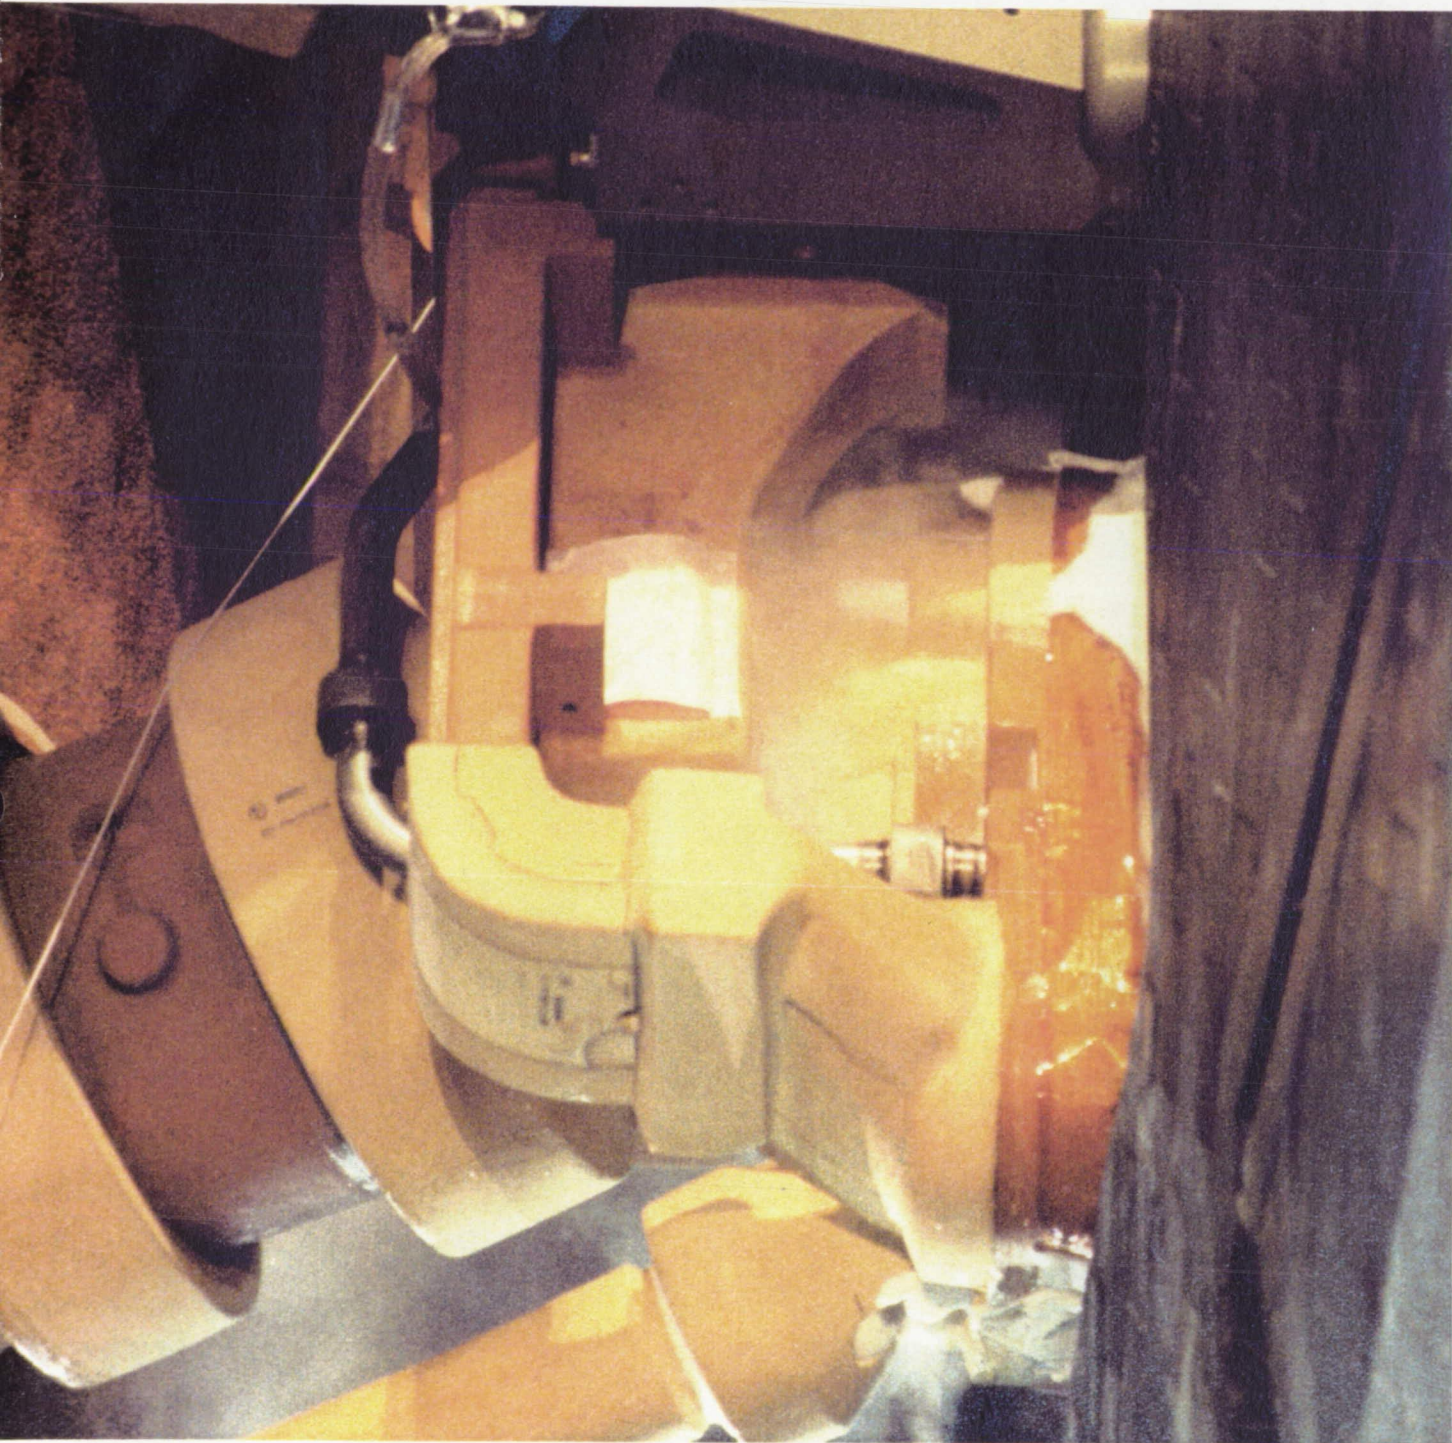
Less than usual ice/frost had formed on the outboard and top sides of the LH2 ET/ORB umbilical/purge barrier. Typical amounts of ice had accumulated on the upper plate gap and pyro canister purge vents, and in the LH2 recirculation line bellows

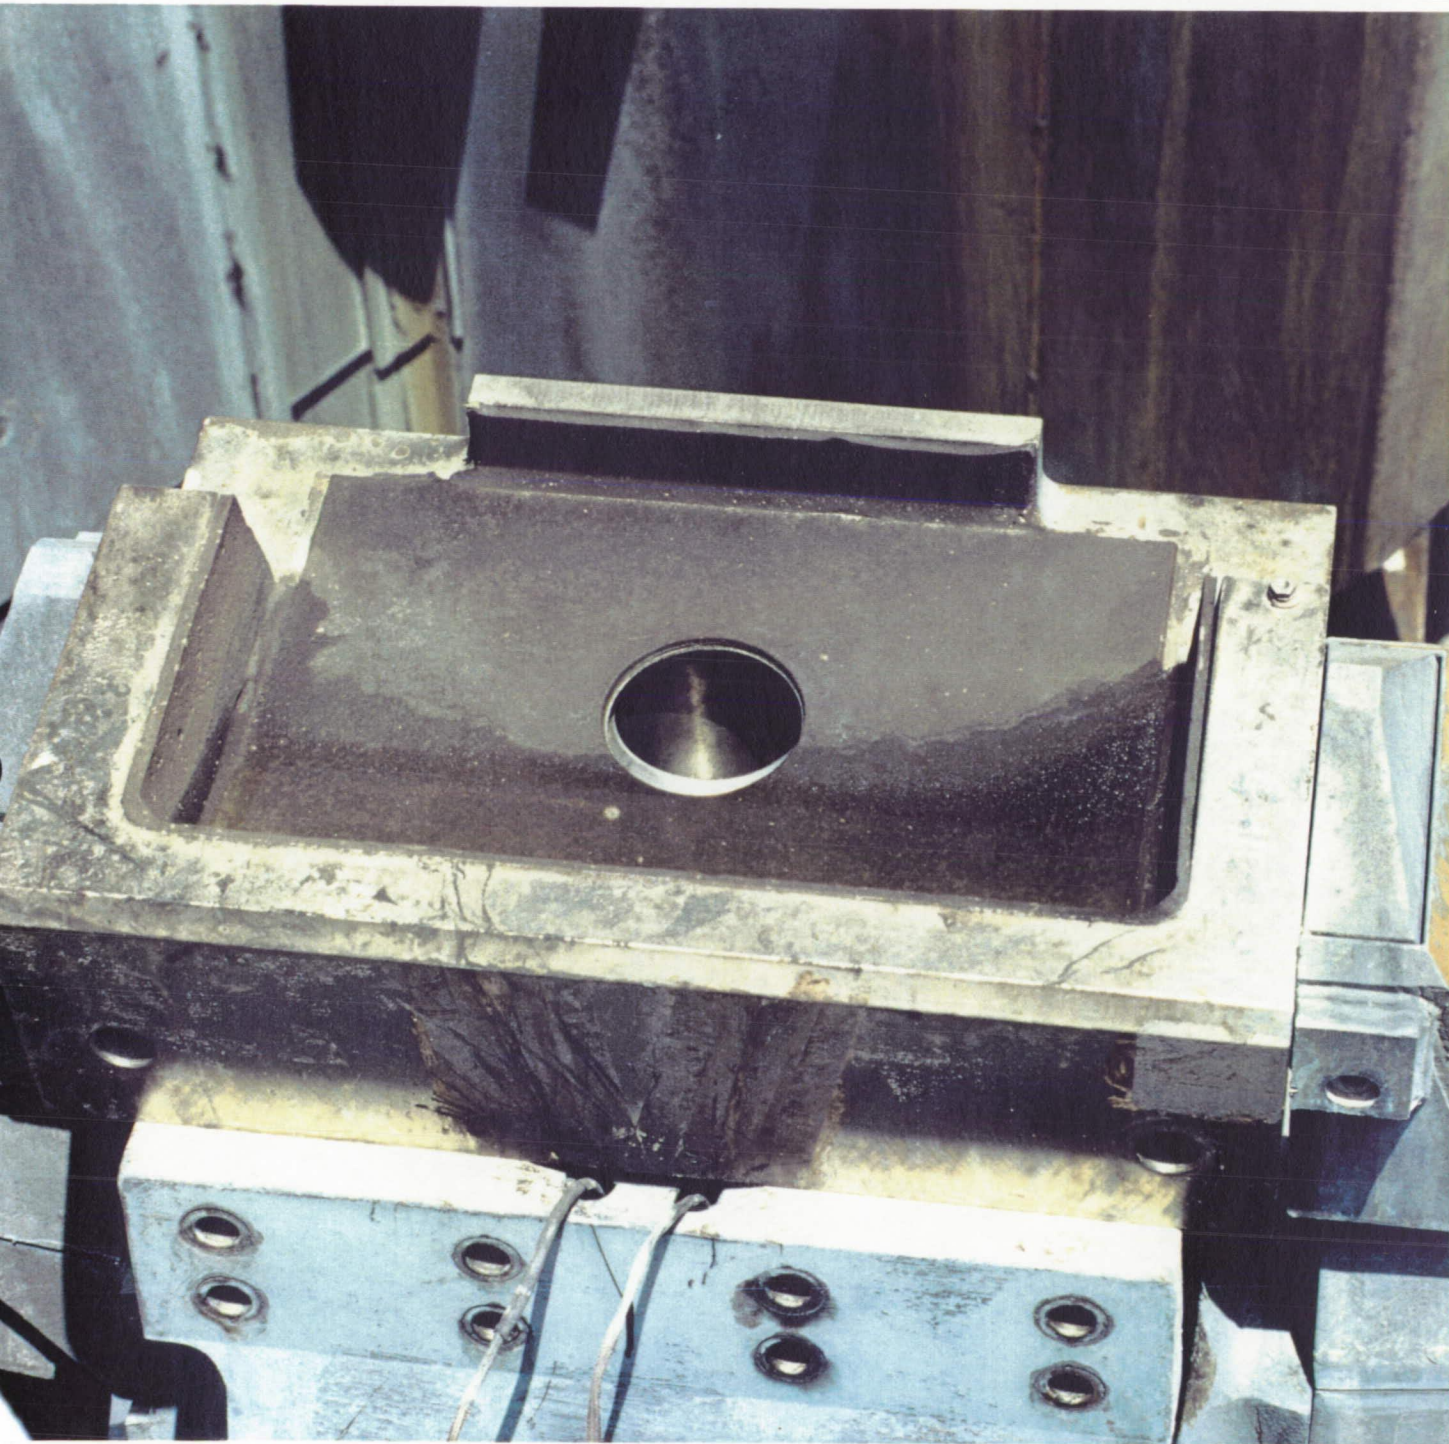
EPON shim material was intact on all south holddown posts. However, the sidewall material was partially debonded on HDP #1 and #5. There was no visual indication of a stud hang-up on any of the south holddown posts. No ordnance fragments were found in the south HDP stud holes. All of the north HDP doghouse blast covers were in the closed position and exhibited less than normal erosion. The SRB aft skirt purge lines were in place but slightly damaged. The SRB T-0 umbilicals exhibited minor damage including deformation of the sacrificial connector savers.

Plume erosion of the south SRB holddown posts was typical. EPON shim material was intact, but debonded along the sidewalls.

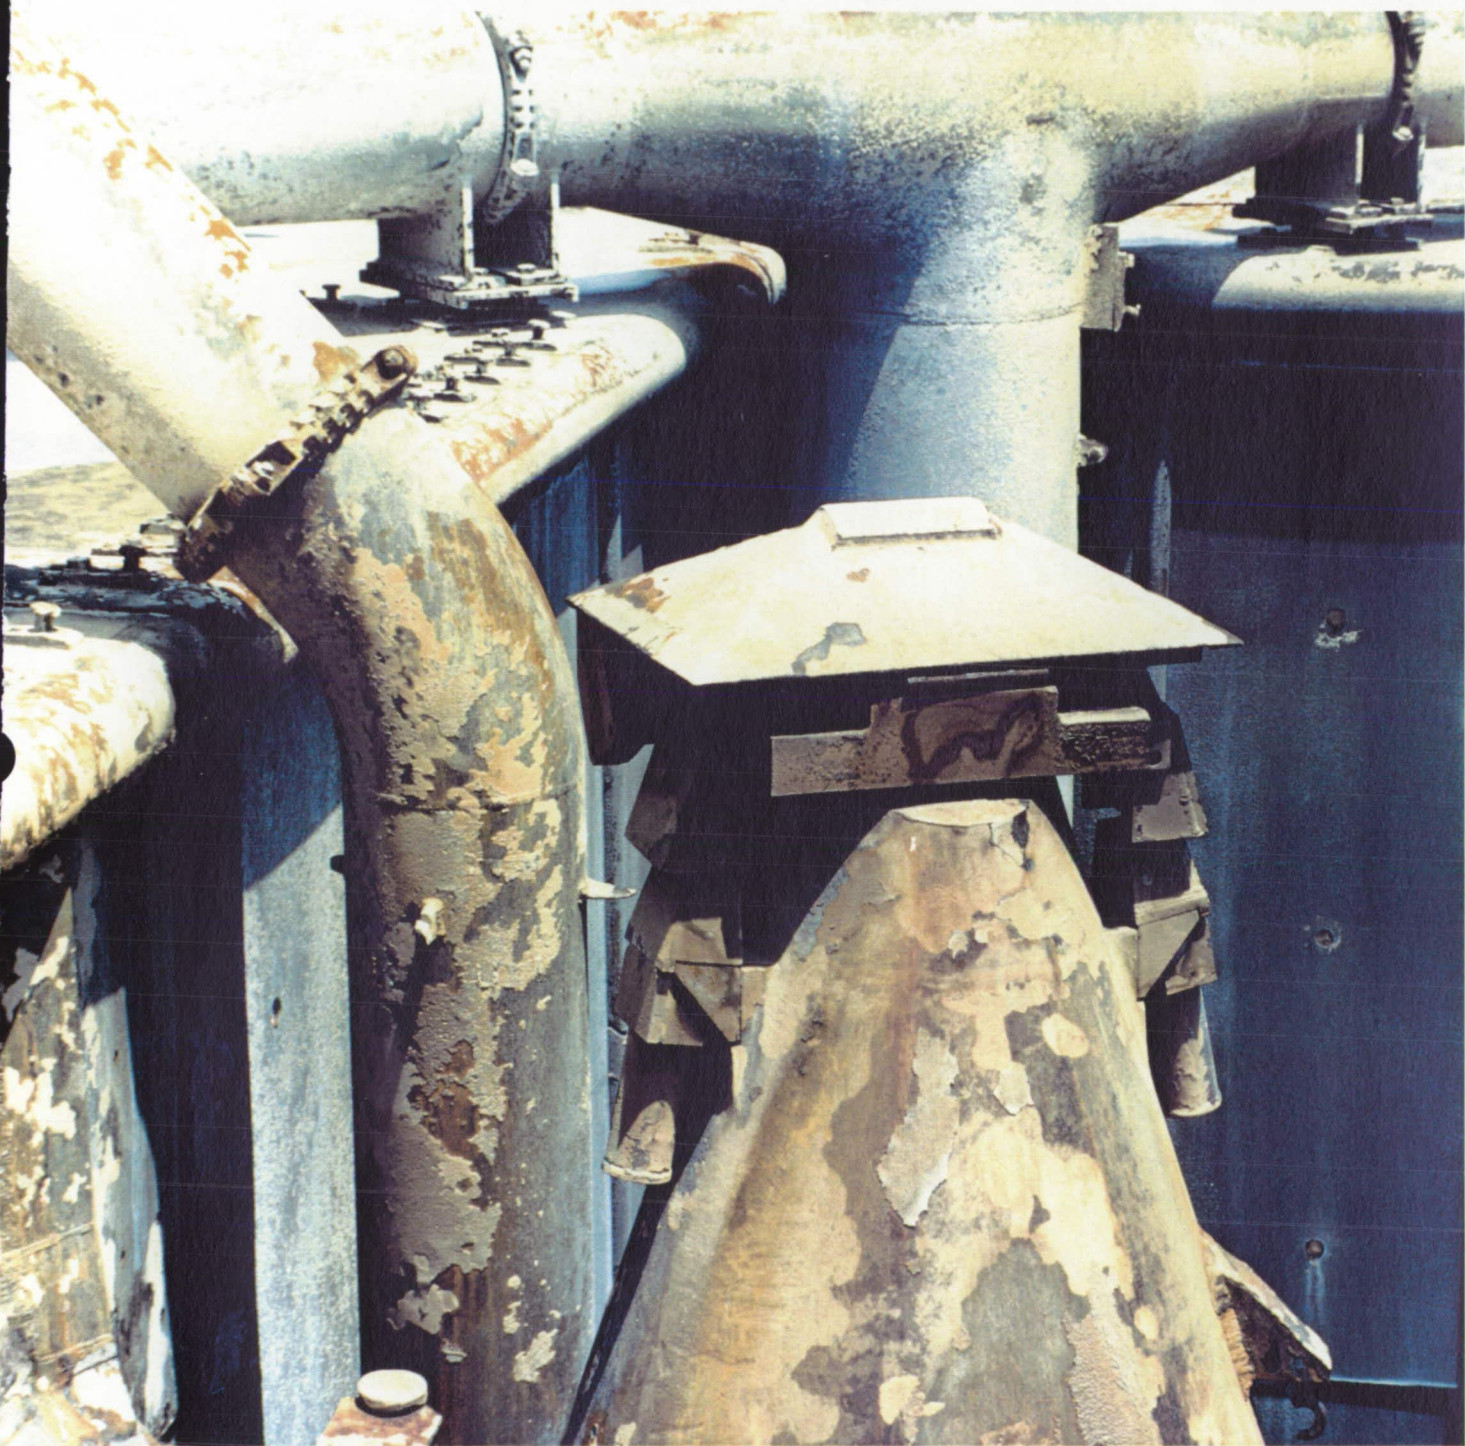
All of the north holddown post doghouse blast covers were in the closed position and showed less than usual erosion

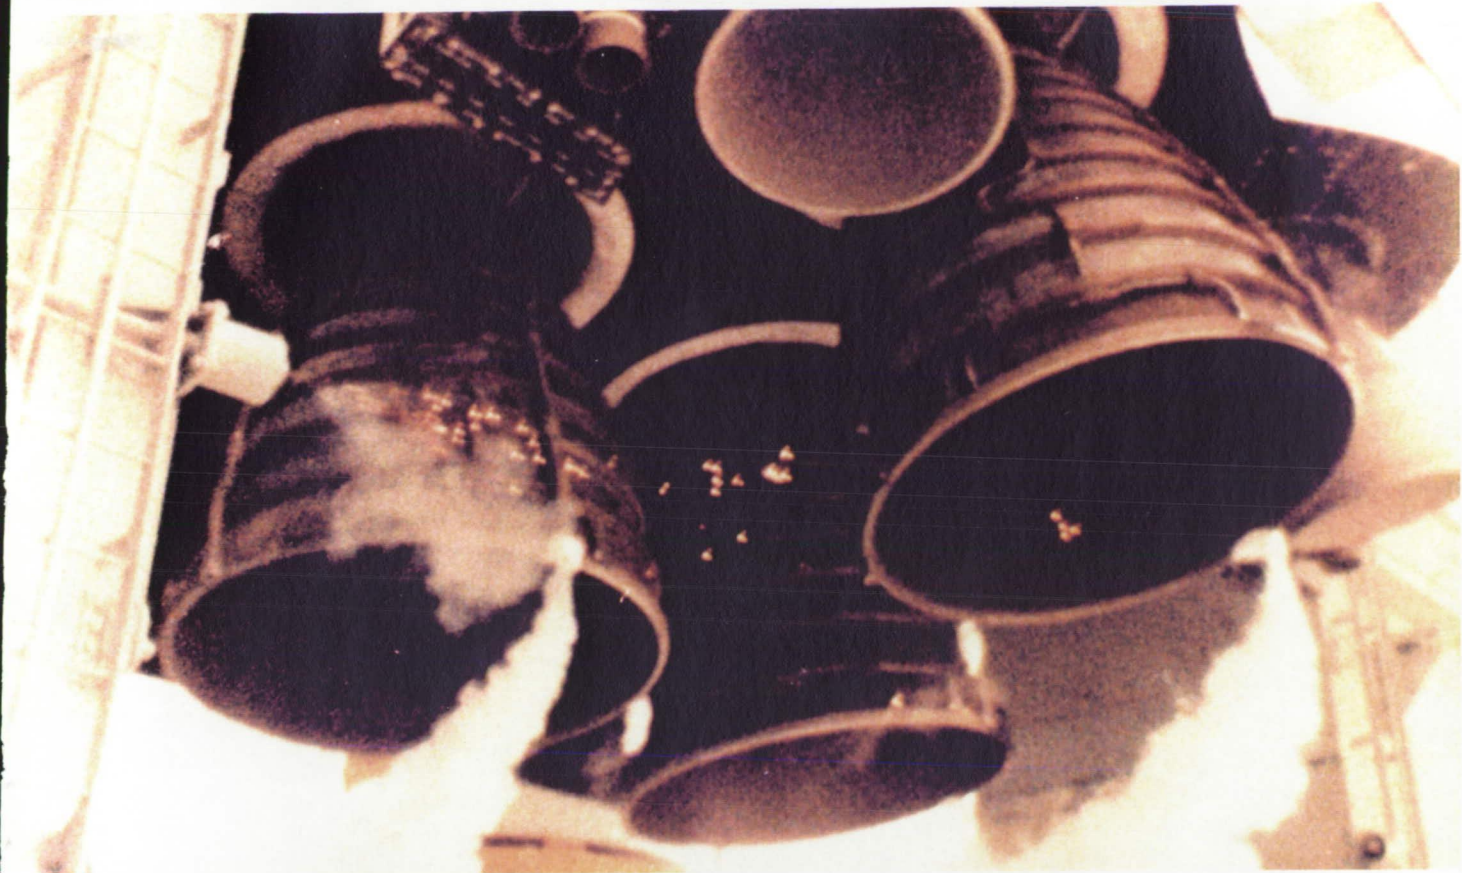
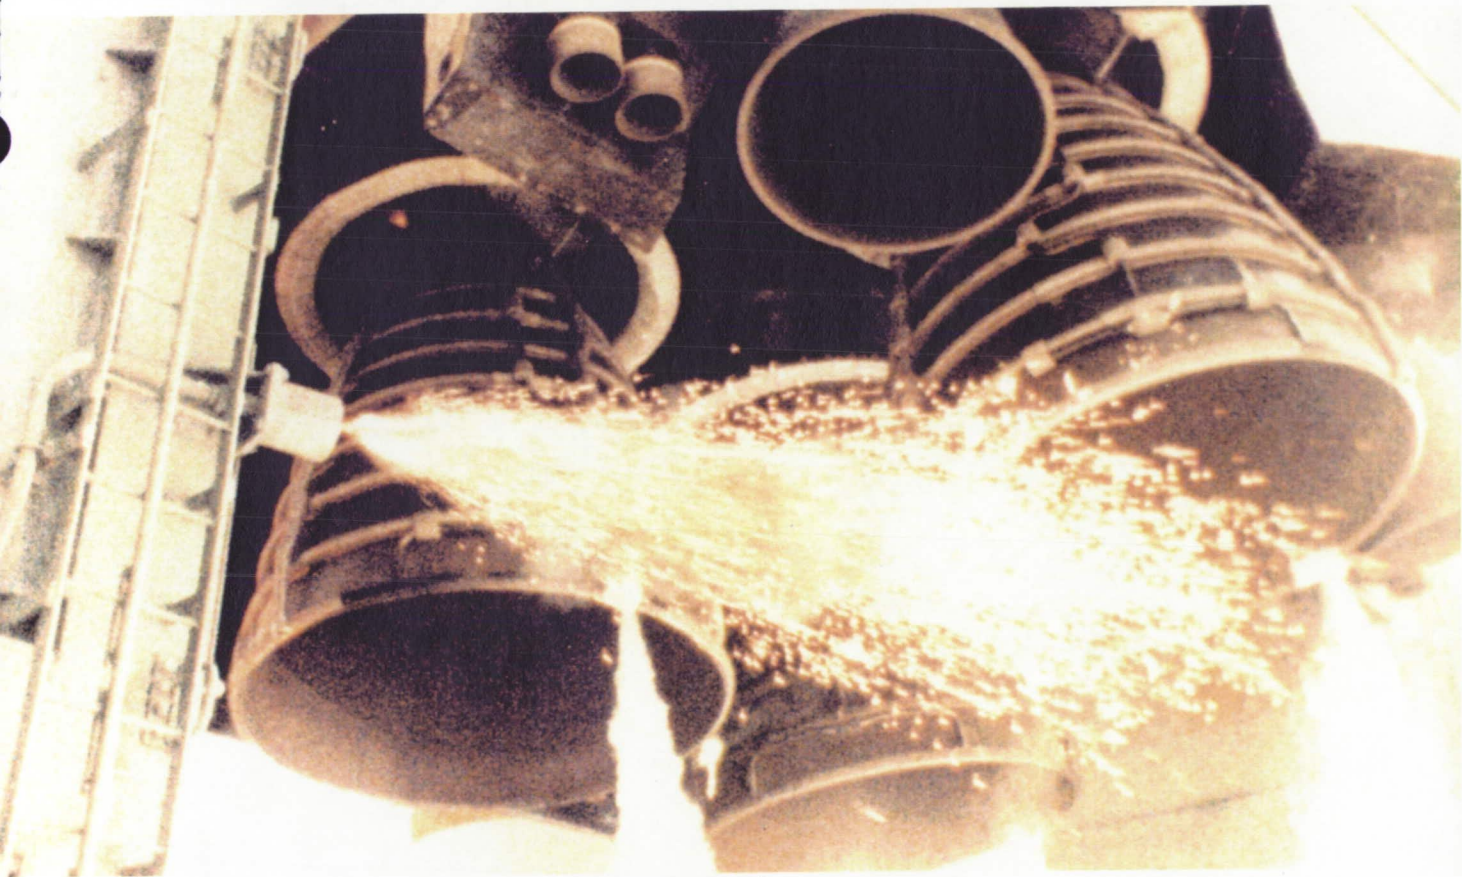
Normal initiation of hydrogen burn ignitor (top) compared to anomalous initiation of STS-46 ignitor (bottom). This ignitor malfunctioned with a faster activation, more concentrated stream of sparks, and was completely expended in 1.3 seconds (nominal burn time is 8 to 12 seconds).

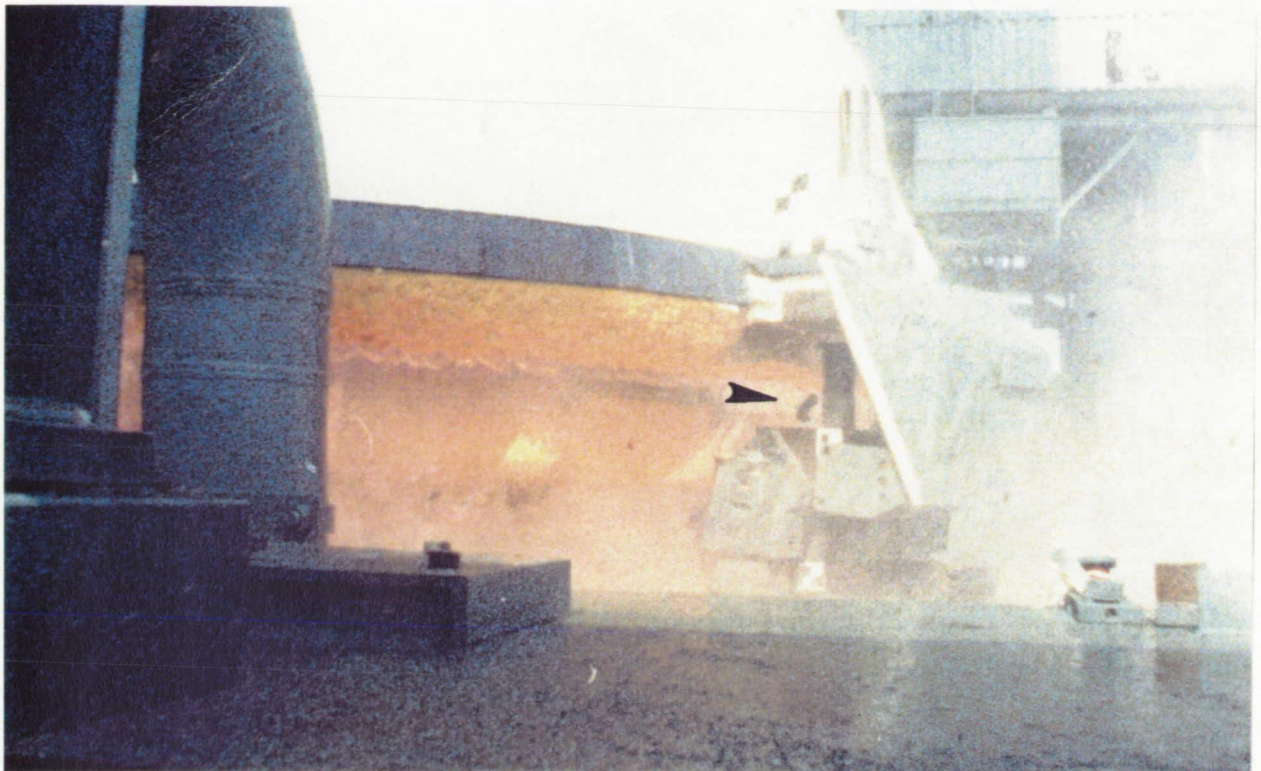
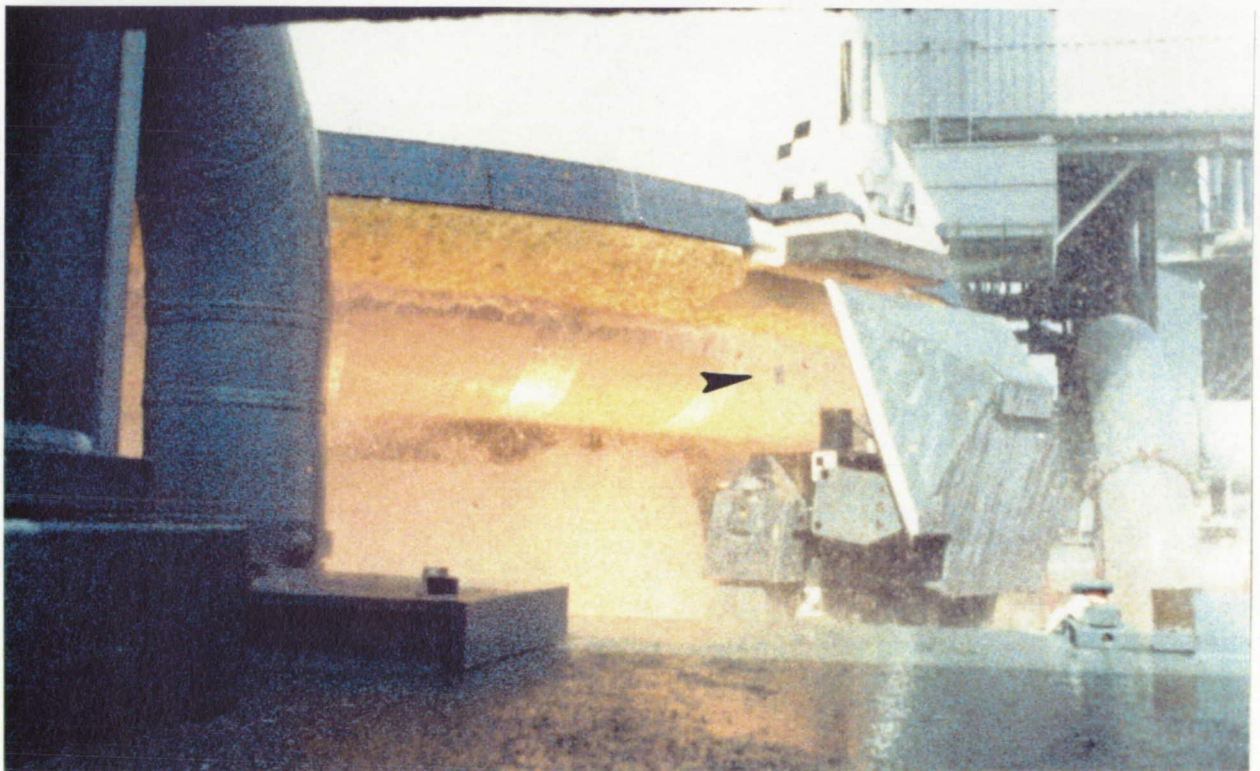
A stud hang-up occurred on HDP #7. The stud remained fully extended as the aft skirt ascended. The stud pulled off three pieces of the EPON shim (arrow) before dropping into the holddown post.
